ENVIRONMENTAL PROTECTION ACT 1990, SECTION 78H(9)

REMEDIATION STATEMENT

Contaminated land caused by communal oil tank, at Wirral View, Connahs Quay, Flintshire. The site is illustrated on the attached map.

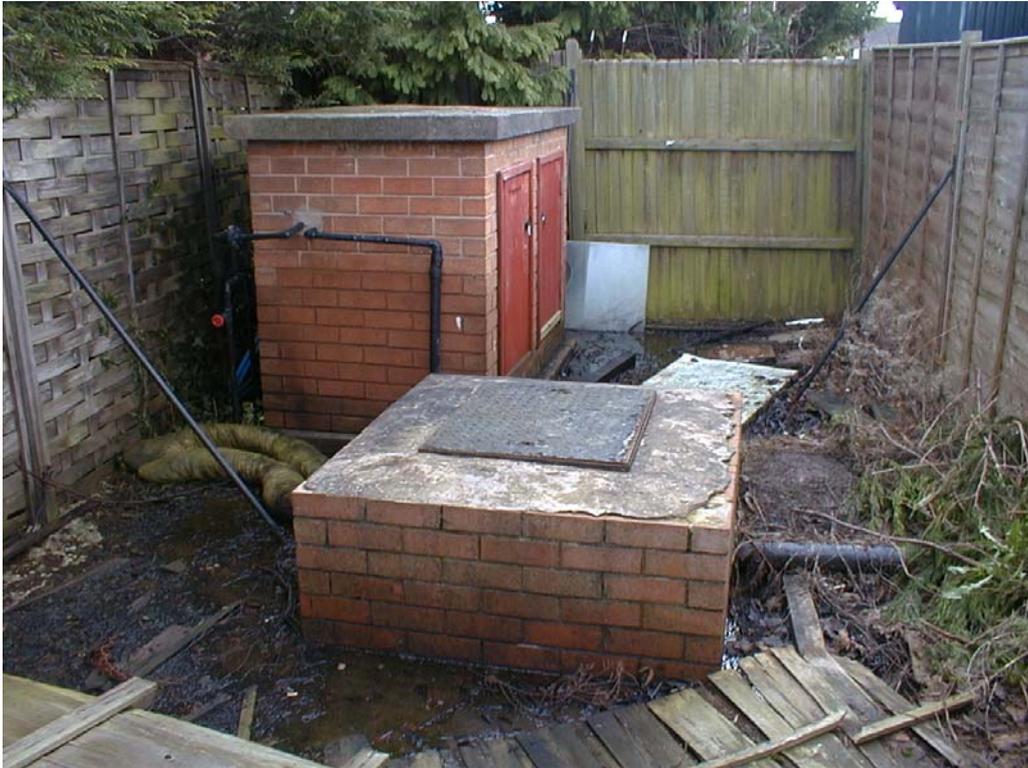
PHOTOGRAPH 1

- A trench, approximately a metre deep, was dug along the length of the supply pipe running along the edge of the communal tank and its concrete bund surrounding the tank and then a visual search was made for any leaks. The trench was dug here on the basis that the oil was found pooled in the tank compound (see photograph 1 attached) and was therefore emanating from somewhere in this area.
- The depth of the communal oil tank was measured.
- The sheath of the supply pipe had been removed in a couple of places to check for any seepage of oil within the sheath.

OIL ON SURFACE OF WATER POOLED WITHIN COMPOUND

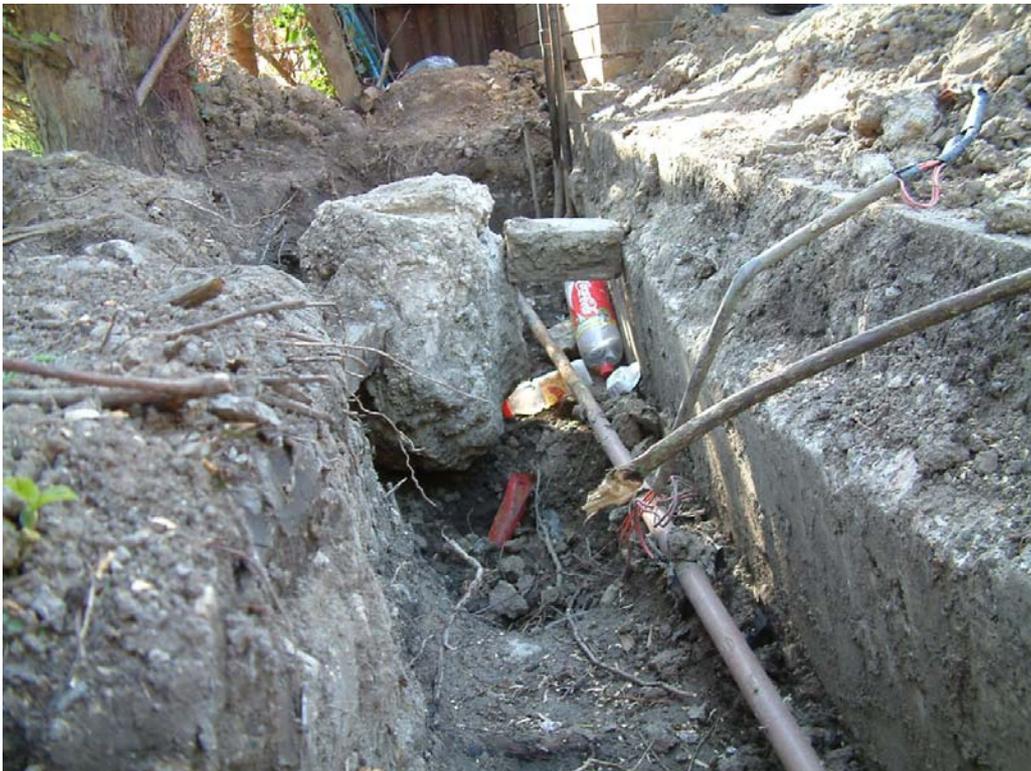
PHOTOGRAPH 2

No holes or damage were found in the supply pipe below ground level and no oil was found within the sheath surrounding the pipe. There was no sign of oil seepage through the concrete bund surrounding the communal oil tank (see photograph 2 attached). The tank was found to be approximately 3.3m deep. The engineer advised that due to the depth of the tank the pressure head would have caused a noticeable amount of oil to leak from the bund either through the bund itself or overflow from the pump well. There was no oil in the pump well.

CONCRETE BUND OF OIL TANK SHOWING NO SEEPAGE OF OIL

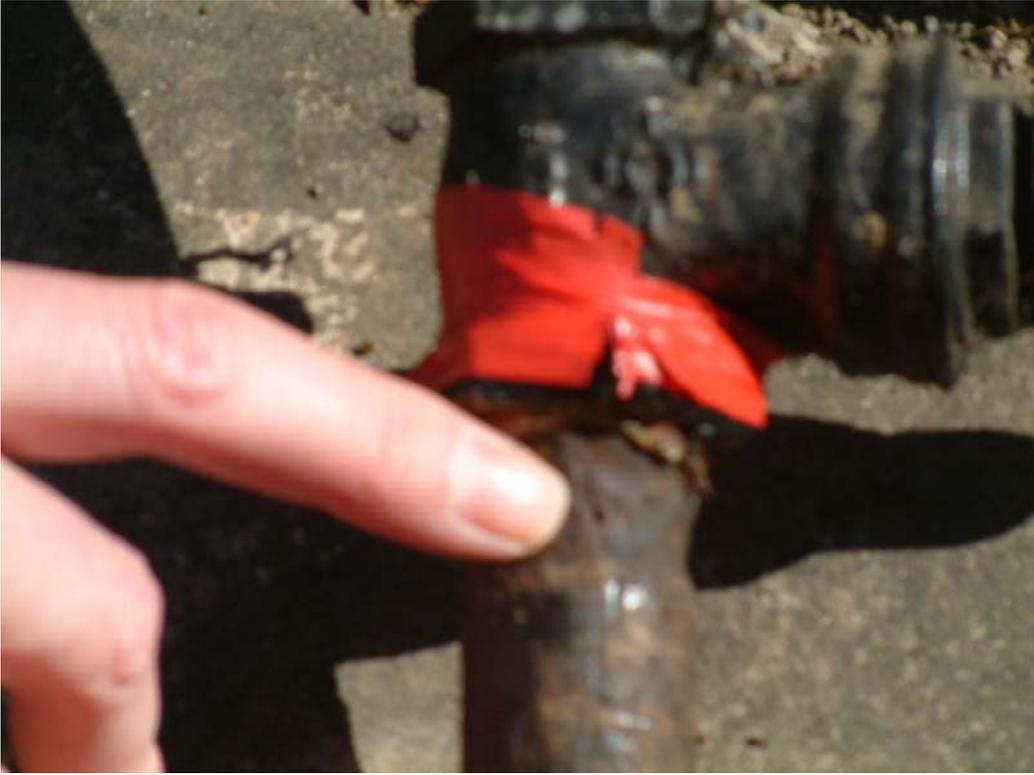
A very small hole about 1 to 2mm in diameter was found on one of the supply pipes under an area covered by denso tape (see photograph 3 attached). This was in a position above ground.

PHOTOGRAPH 3
HOLE IN SUPPLY PIPE

The section of pipe with the hole in was replaced by a new piece of pipe (see photograph 4 attached).

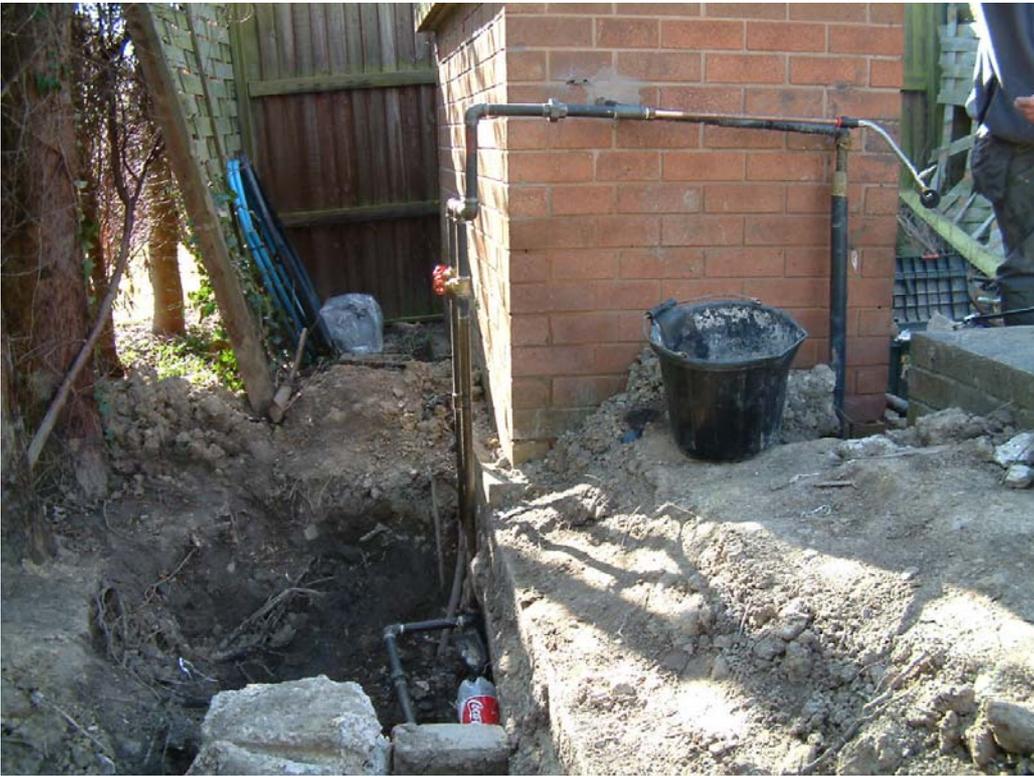
PHOTOGRAPH 4
NEW SUPPLY PIPE WITH PRESSURE METER ATTACHED

- Blocking off the oil supply to those dwellings still utilising the fuel;
- Disconnecting the two pipes from the tank (see photograph 5 attached), which run in a circuit;
- Draining down the oil from the supply pipes;
- Applying a pressure meter to the circuit (see photograph 4 attached).

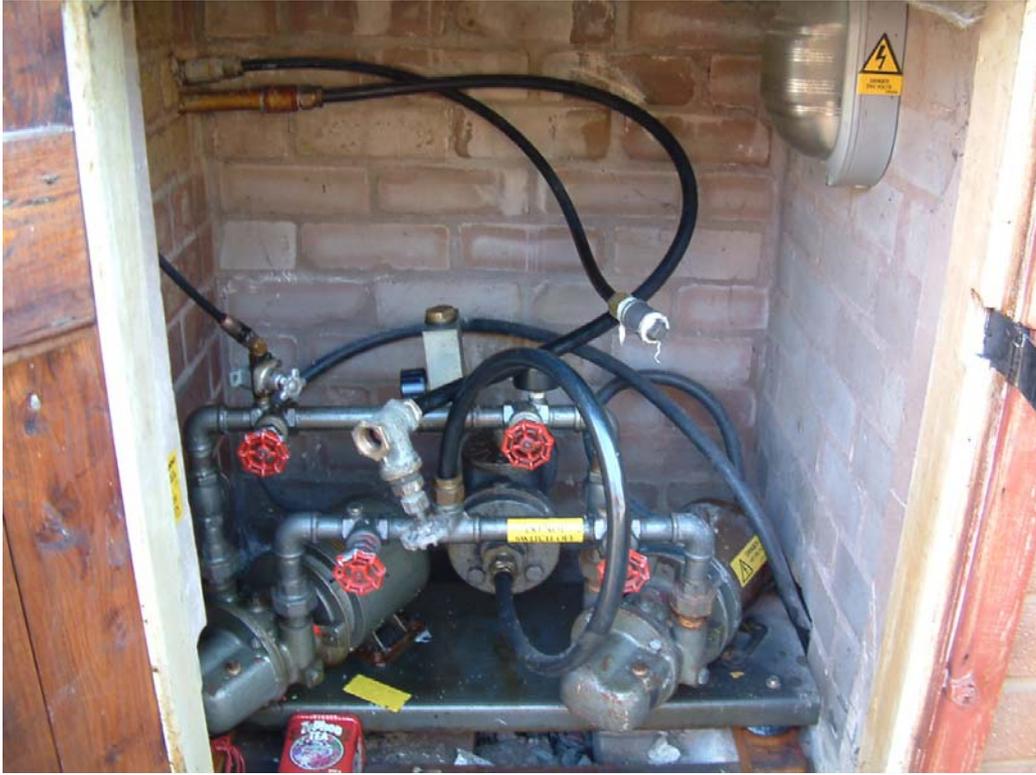
PHOTOGRAPH 5

TWO SUPPLY PIPES DISCONNECTED FROM THE TANK

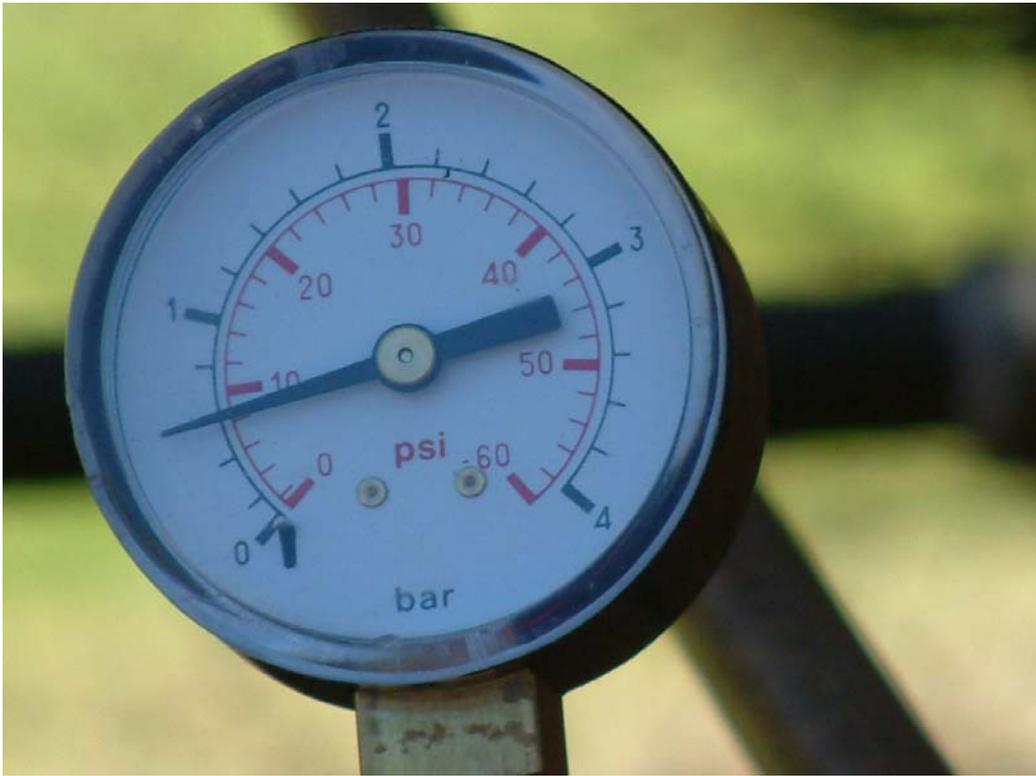
PHOTOGRAPH 6

The pressure meter was left on for approximately half an hour. This did not drop from 0.5 bar over the half hour period (see photograph 6 attached).

PRESSURE METER DISPLAYING THE READING OF 0.5 BAR
