Environment Directorate
Public Rights of Way

Annual Report

Public Rights of Way | 2013-2014

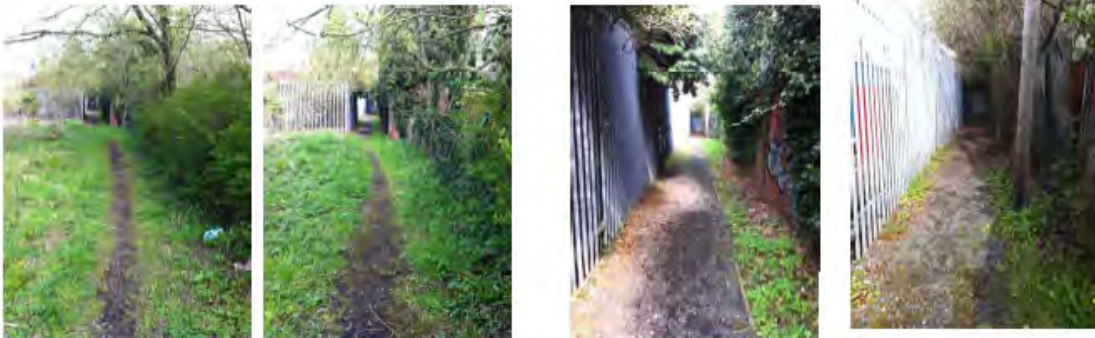
Pre scheme photographs

The path continues between a security fence to the left and chain link fence to the right. The path surface at this location was tarmac but had a lot of moss growing from its surface. The path did eventually become slightly drier as it entered open scrub land.

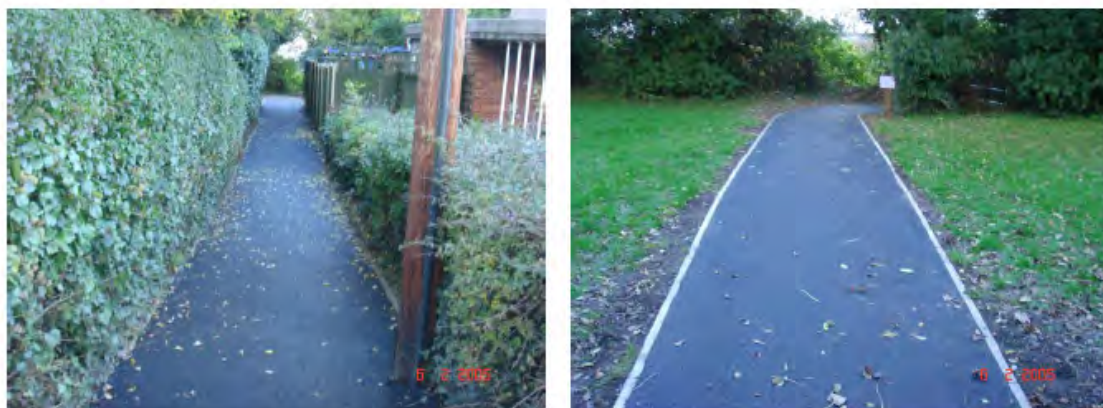
Post Scheme Photographs

Resurfaced path with edging kerbs from ffordd Ddyfrdwy through the open space.

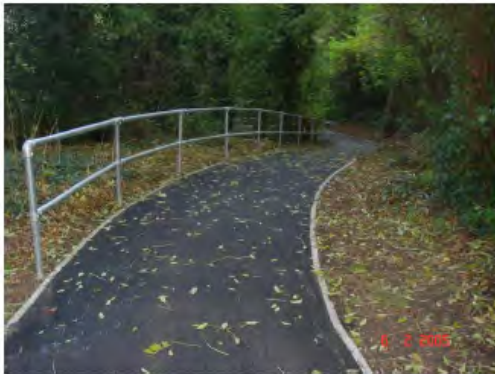
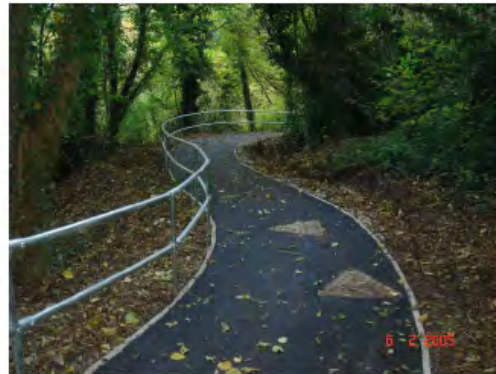
Post Scheme Photographs

A new handrail has been installed in the copse area and a new footpath surface with edging kerbs.

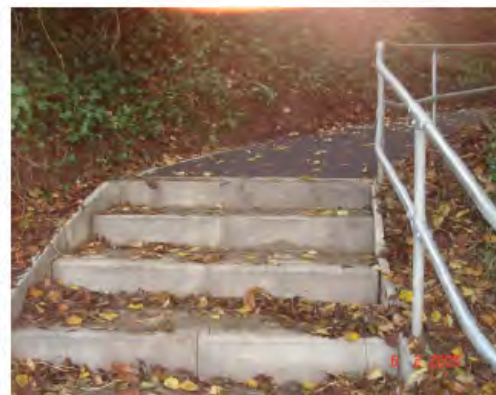
Post Scheme Photographs

The drainage issue has now been resolved and new concrete steps have been installed.

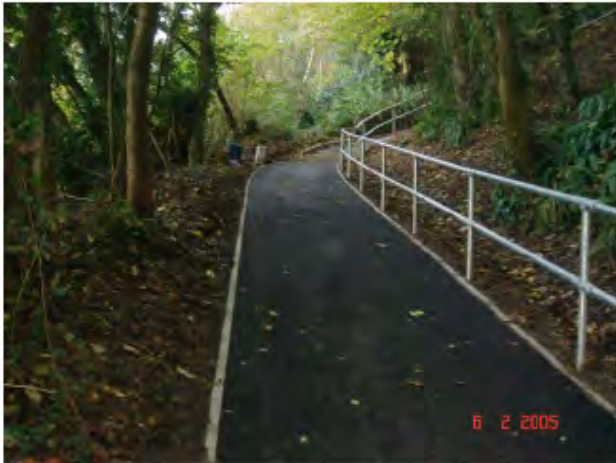
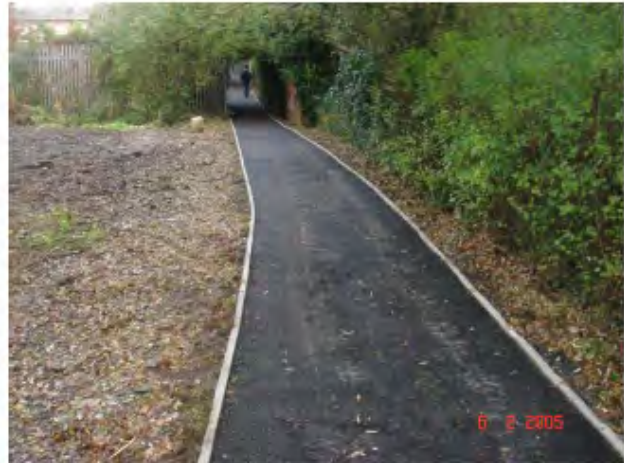
Post Scheme Photographs

A new footpath has been laid through the open scrubland to the junction with the A548.

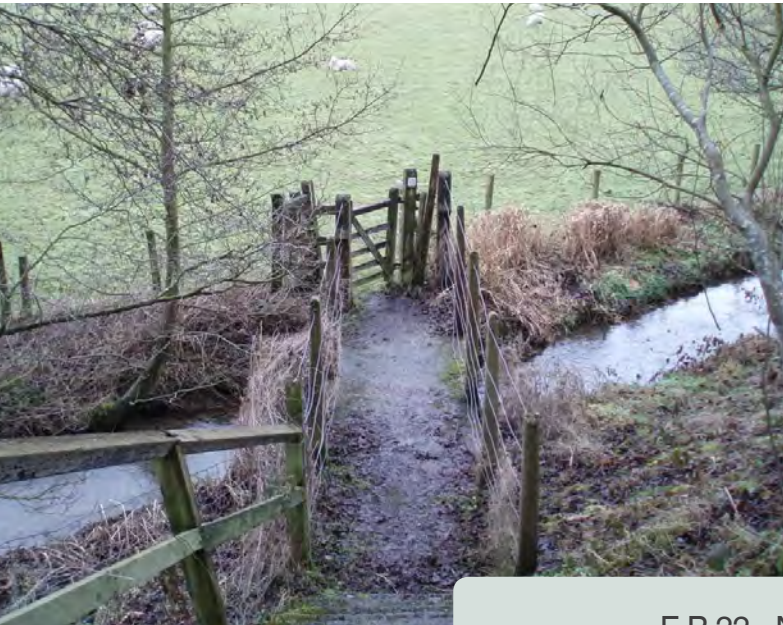
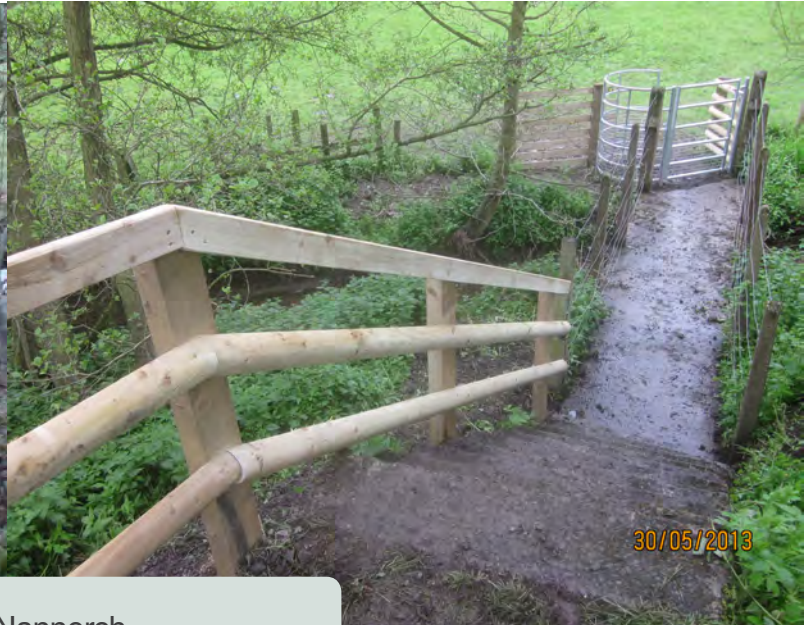
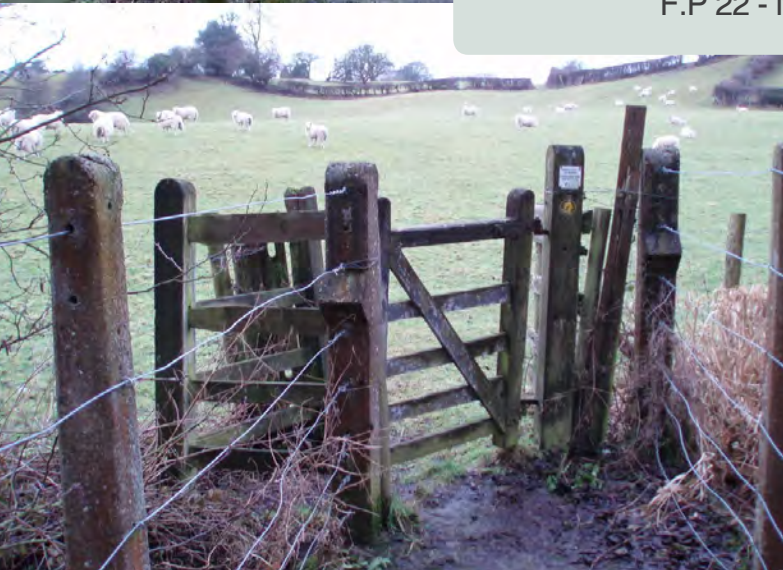
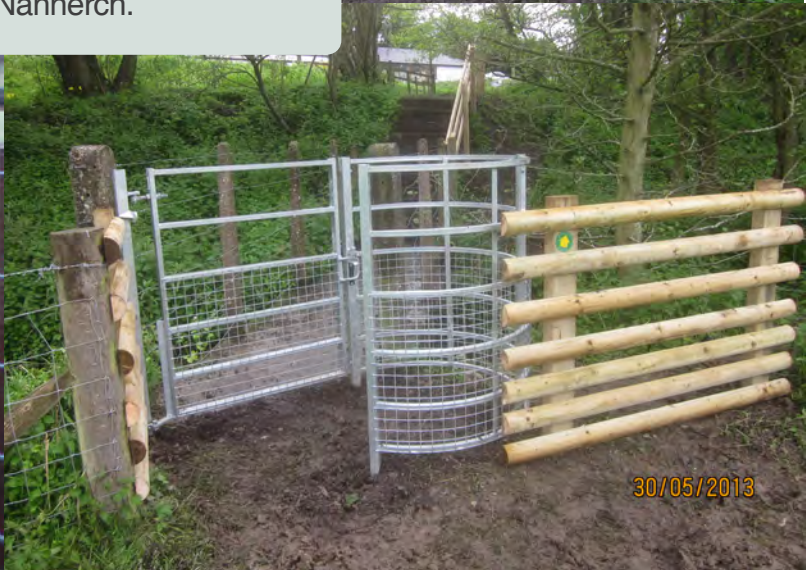
F.P 22 - Nannerch.

The old wooden kissing gate on a popular local walk needed to be replaced as it had fallen into disrepair. It was replaced with a modern stainless steel version and new fencing was erected either side of it. The hand rail along the steps leading to the kissing gate was replaced and the steps were given a general spruce-up.

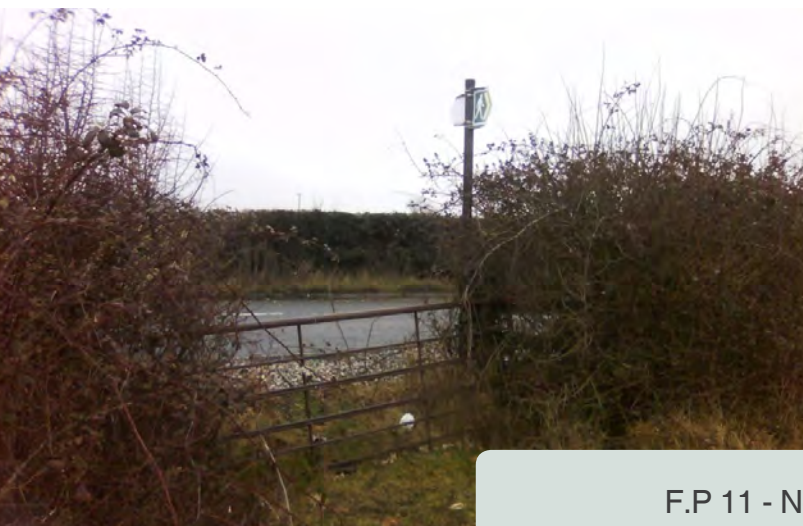
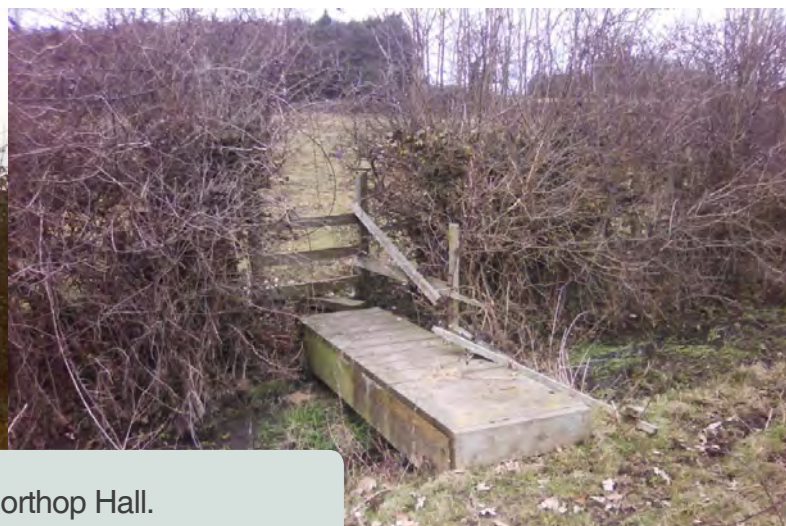
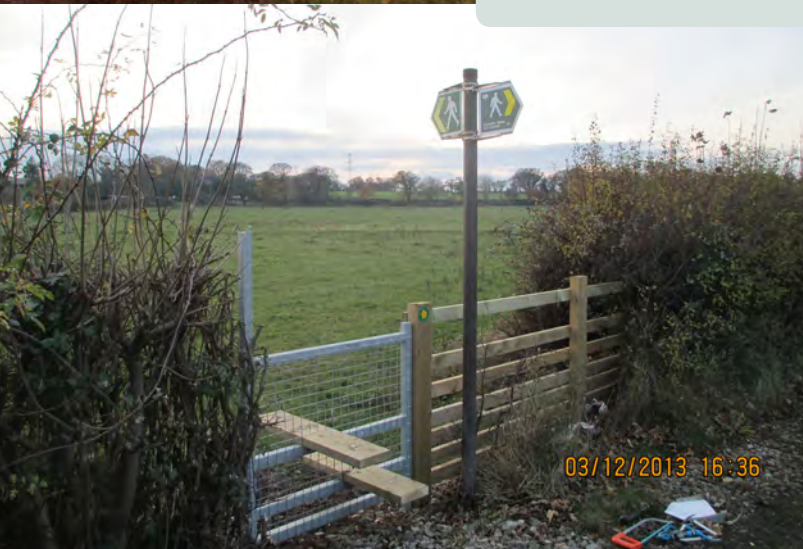
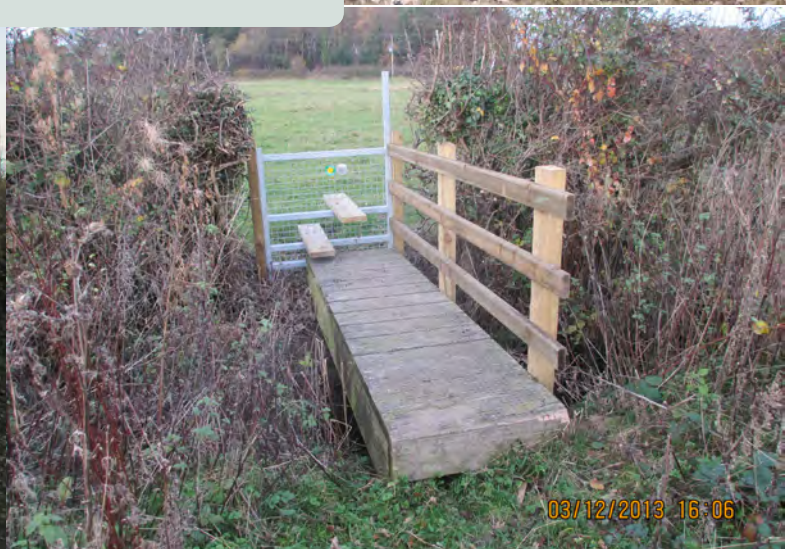
F.P 11 - Northop Hall.

At the next site which was on the opposite side of the road to the first, the stile had become overgrown by the hedge and walkers had started to access the path by climbing over the field gate. The hedge was cut back and the stile replaced with a metal one.

At the third site the stile and hand rail associated with the decking bridge over a ditch was dilapidated and needed replacing. As well as renewing the stile and hand rail mesh was laid on the decking to improve grip. Finally at the last location a stile in the hedge line was replaced with a metal version.

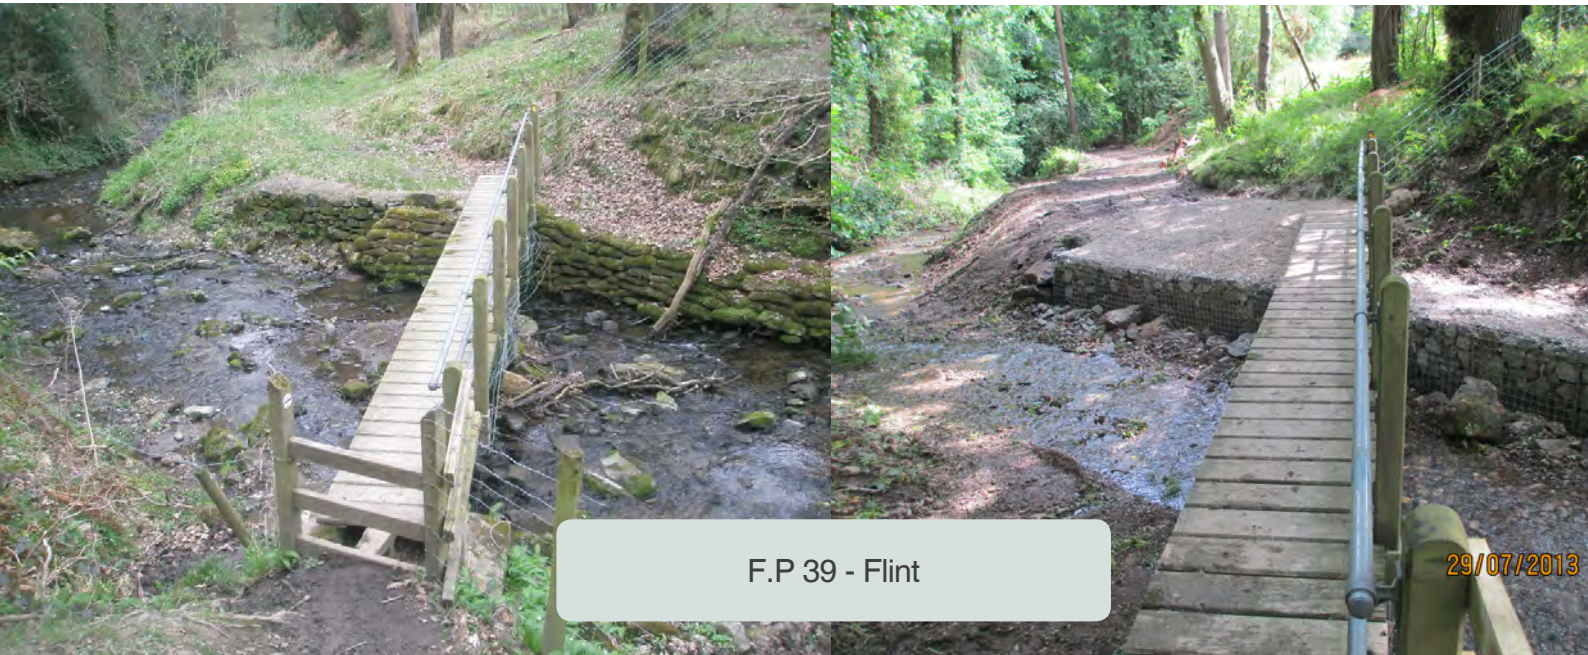
Footpath 39, Flint

Flooding of the river had seriously undermined the sand bag wall supporting a bridge at a remote location on this path. The remoteness of the site meant that it was difficult to get the materials and equipment needed for the remedial work close to the location and this meant most of what was used had to be manhandled to site. The sand bags were removed and replaced with 8 gabion baskets filled on site with 25 mm stone. The stream had to be diverted away from the site of the work so that a trench could be dug into which the gabions were positioned and this required the bridge to be temporarily removed. Whilst the work took place a structure made from hessian was strung across the stream to trap as much silt as possible to limit any possible pollution.

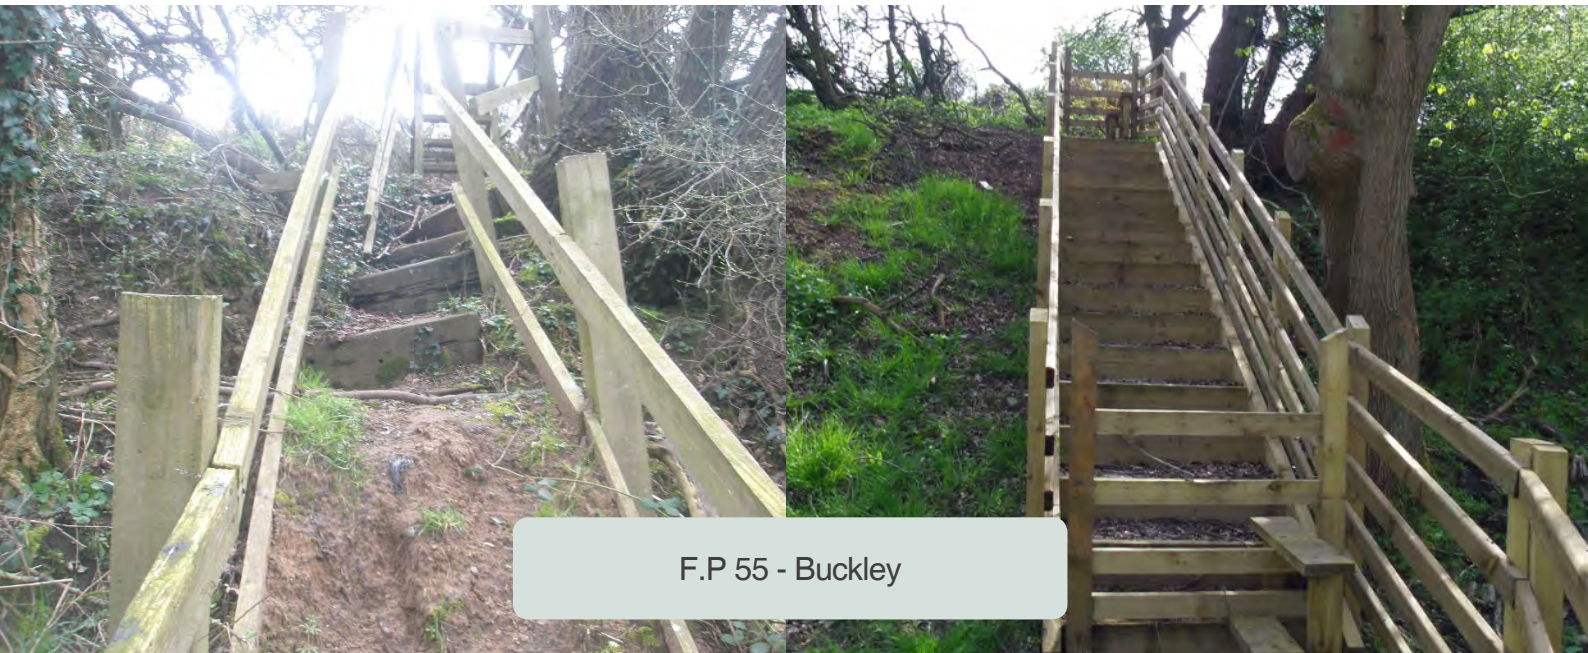
Footpath 55, Buckley

This footpath provides a well-used link to the old disused railway embankment and to nearby Watts Dyke Way. The steps up the embankment had fallen into disrepair and were difficult to negotiate. Before work could commence contact had to be made with the County Ecologist as the steps were close to a live badger sett. As a result restrictions were placed on the work which allowed only hand tools to be used to carry out the work. This obviously had a major impact on the job with regard to the length of time to carry it out and with the physical effort required without the use of any form of

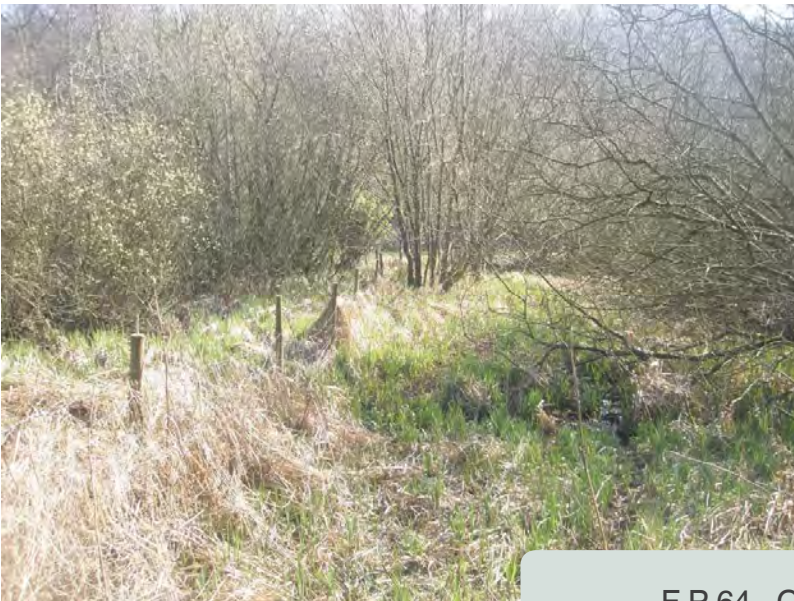
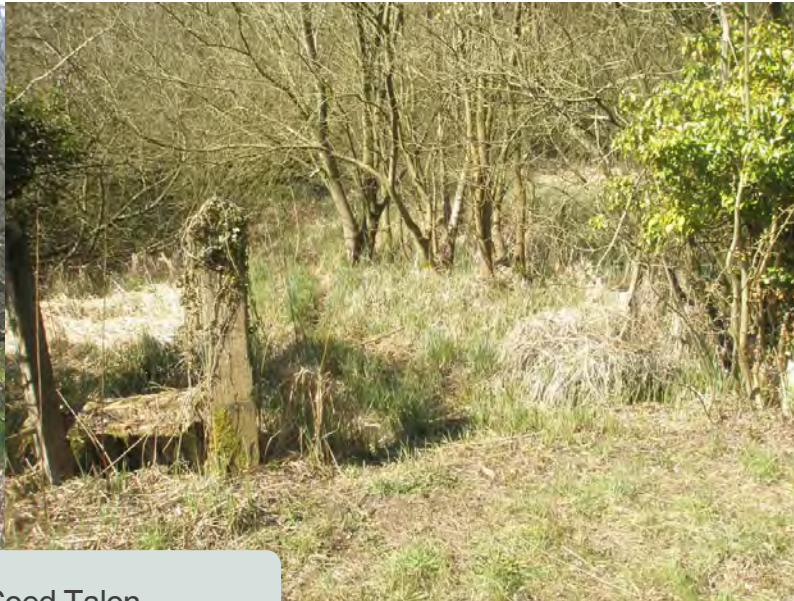
F.P 64 - Coed Talon

This path provides access to a local nature reserve and an area of SSSI. A 6 metre board walk was constructed and erected over a point of permanent standing water and two flights of steps of over twenty steps each were constructed to and from the board walk. As the site is within an SSSI permission was required from Natural Resources Wales to carry out the work and a risk assessment had to be prepared.

The footpath is well used locally and has become unsafe due to the area being wet and boggy.

Site at present, removal of scrub trees to right of concrete post.

- Removal of existing stock fence from site, approx 45 mtrs.
- Installation of a wooden boardwalk 35mtrs in length by 1.2mtrs in width, using approved treated timber specified in line with BS 8417.
- Removal of a number of self seeded scrub trees to accommodate the construction of the boardwalk and increase clearance height for walkers once the boardwalk is constructed.
- Remove existing wooden hanging post and replace with new, realign existing concrete post and hang 12ft wooden gate.

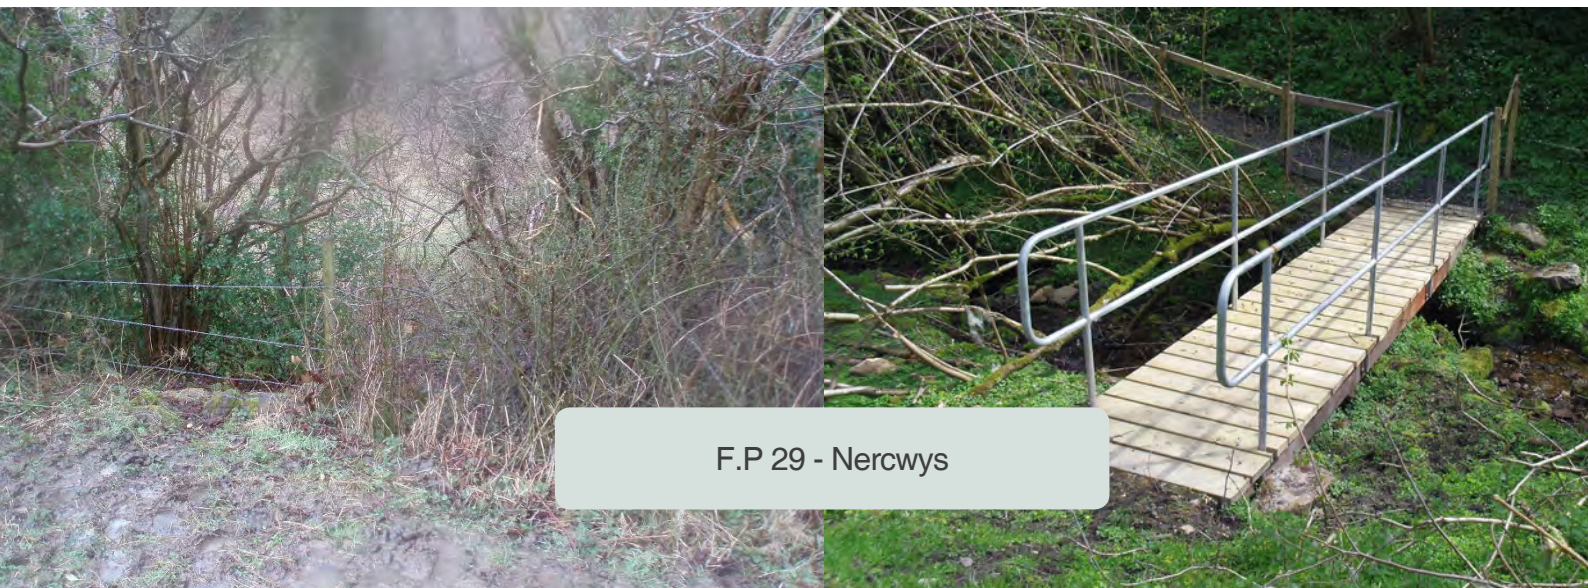
Footpath 29, Nercwys

A 6 metre wooden bridge was erected to replace one that had fallen into disrepair over a local stream. A set of steps were also erected providing access to the bridge.

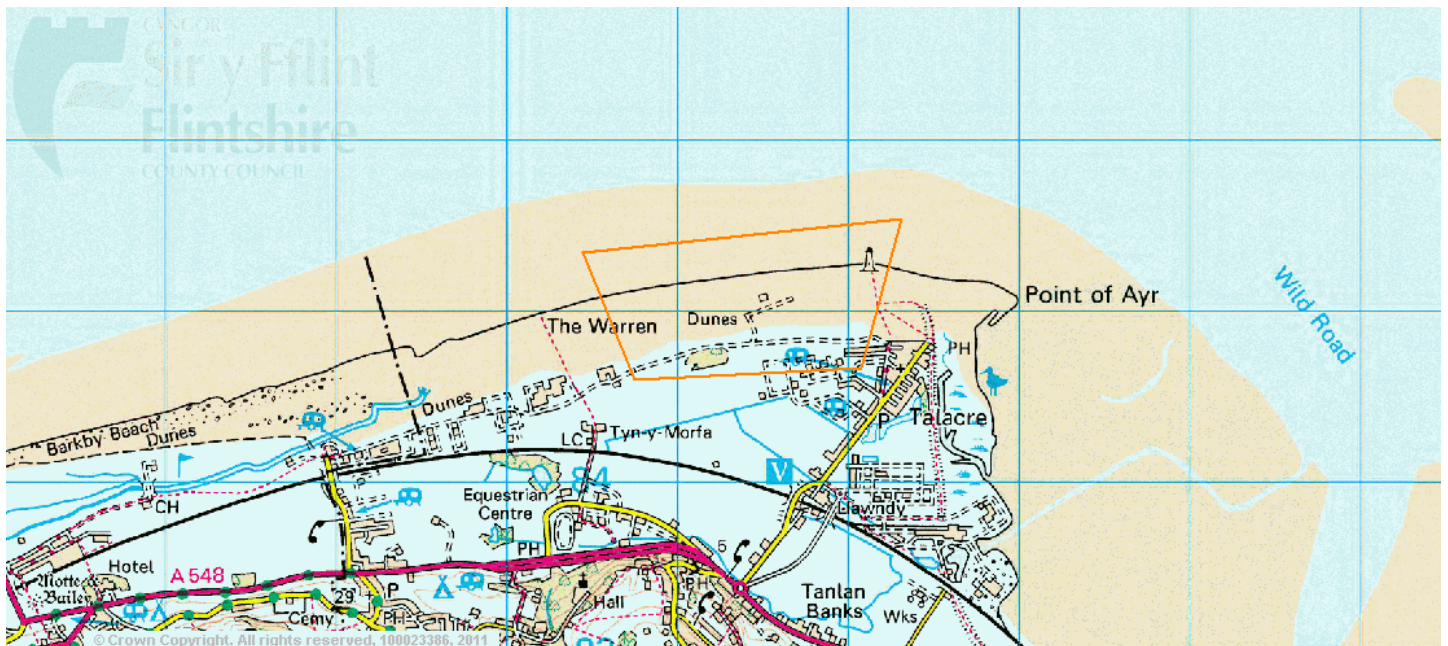
There has been significant damage and disruption to the sand dune system to the west of Talacre with at least one breach to the outer dune system. Ownership and maintenance responsibilities are being confirmed. FCC undertook a beach recharging exercise in conjunction with CCW in 2003. Subsequently, in 2012, further work took place to build up low spots within the rear dune system.

No flooding of property reported.

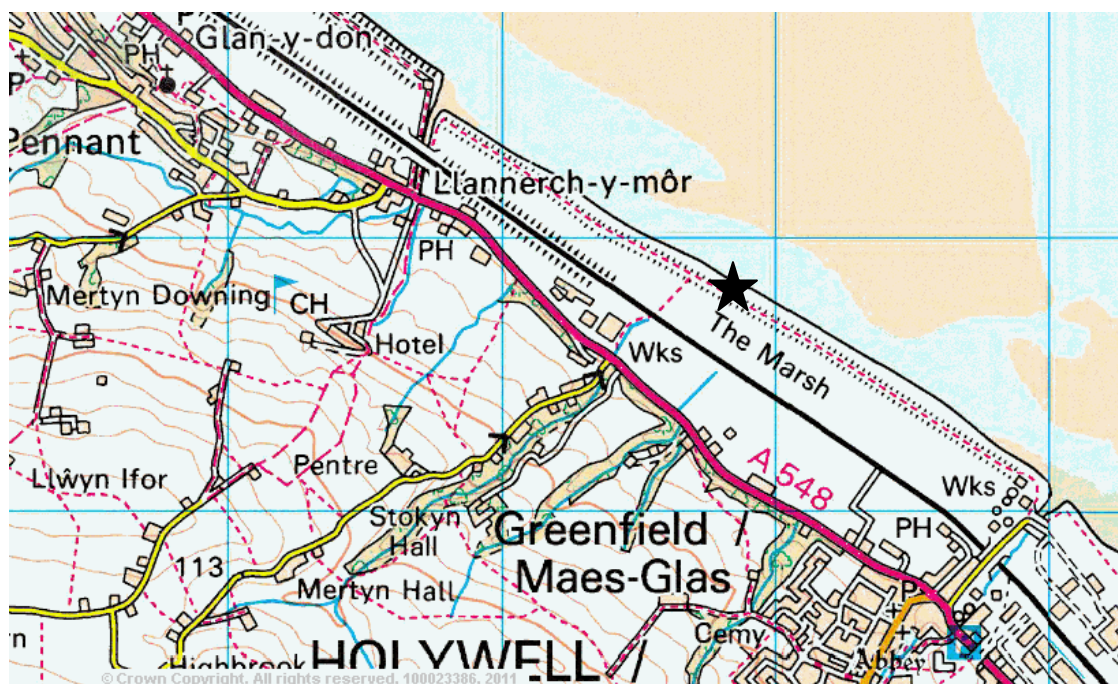
3. The Marsh, Llanerch Y Mor

There is damage to the main (seaward) embankment along its 2.5km length. Overtopping appears to have occurred with rock armour thrown inland. A 15m breach to ground level in the secondary (set back) embankment has occurred approximately halfway along. Extensive flooding to agricultural land but no reported flooding to property.

» Star indicates approx location of breach.

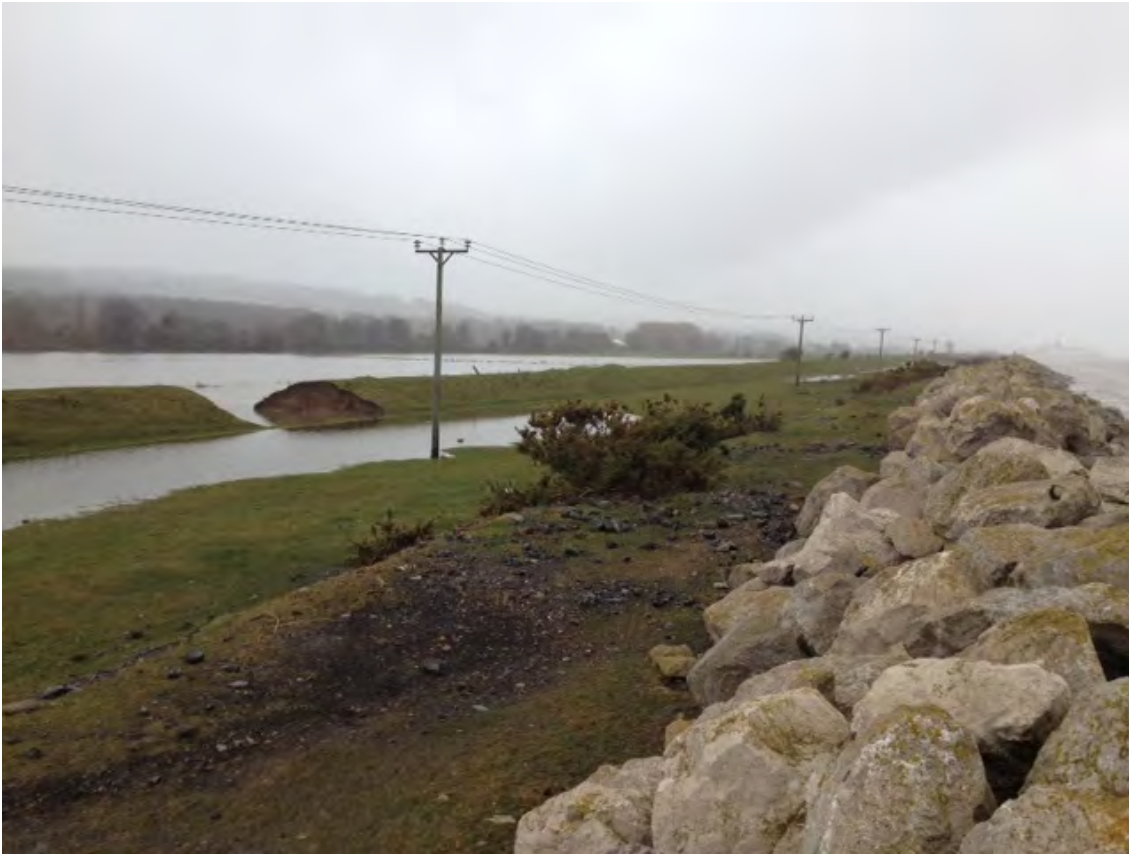
» Breach on secondary embankment approx halfway between Greenfield Dock and Llanerch Y Mor

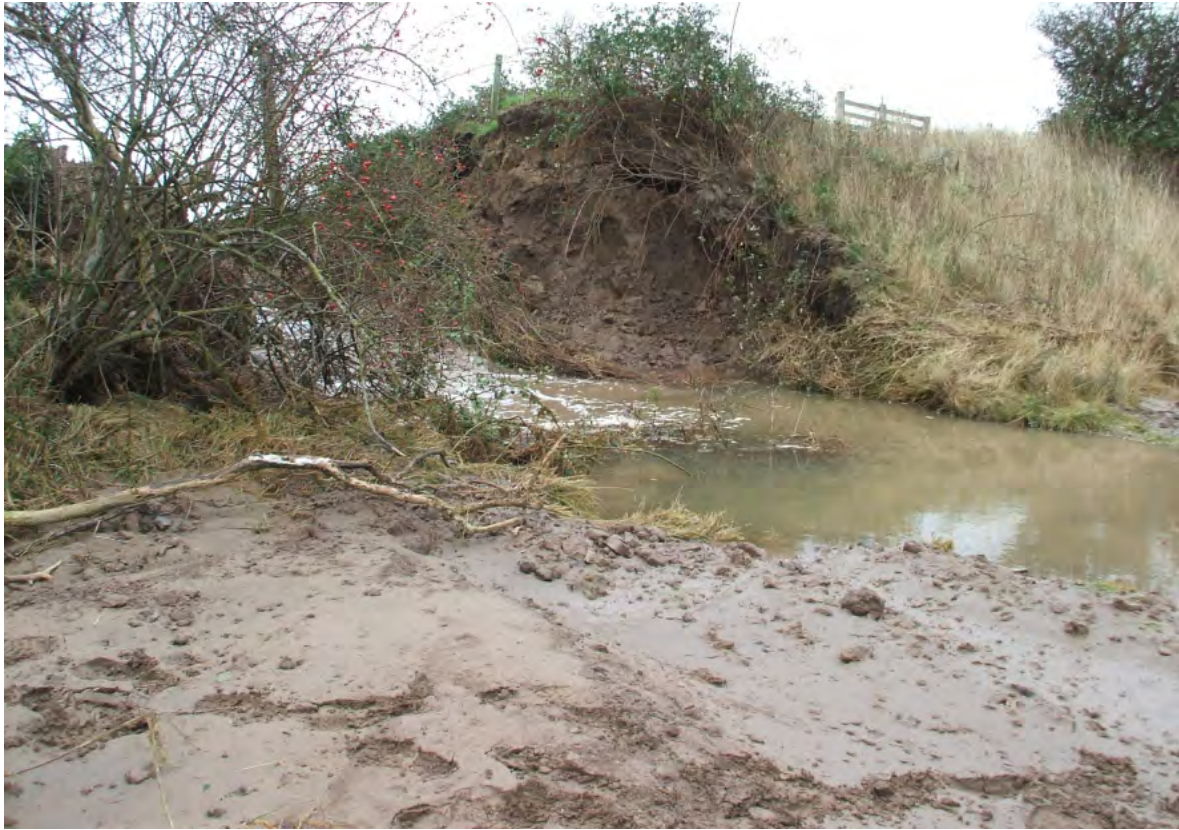
4. Greenfield Marsh 2

There are at least 3 known breaches to ground level of this embankment. Flooding to agricultural land but no reported flooding to property.

» Main breach approx 15m

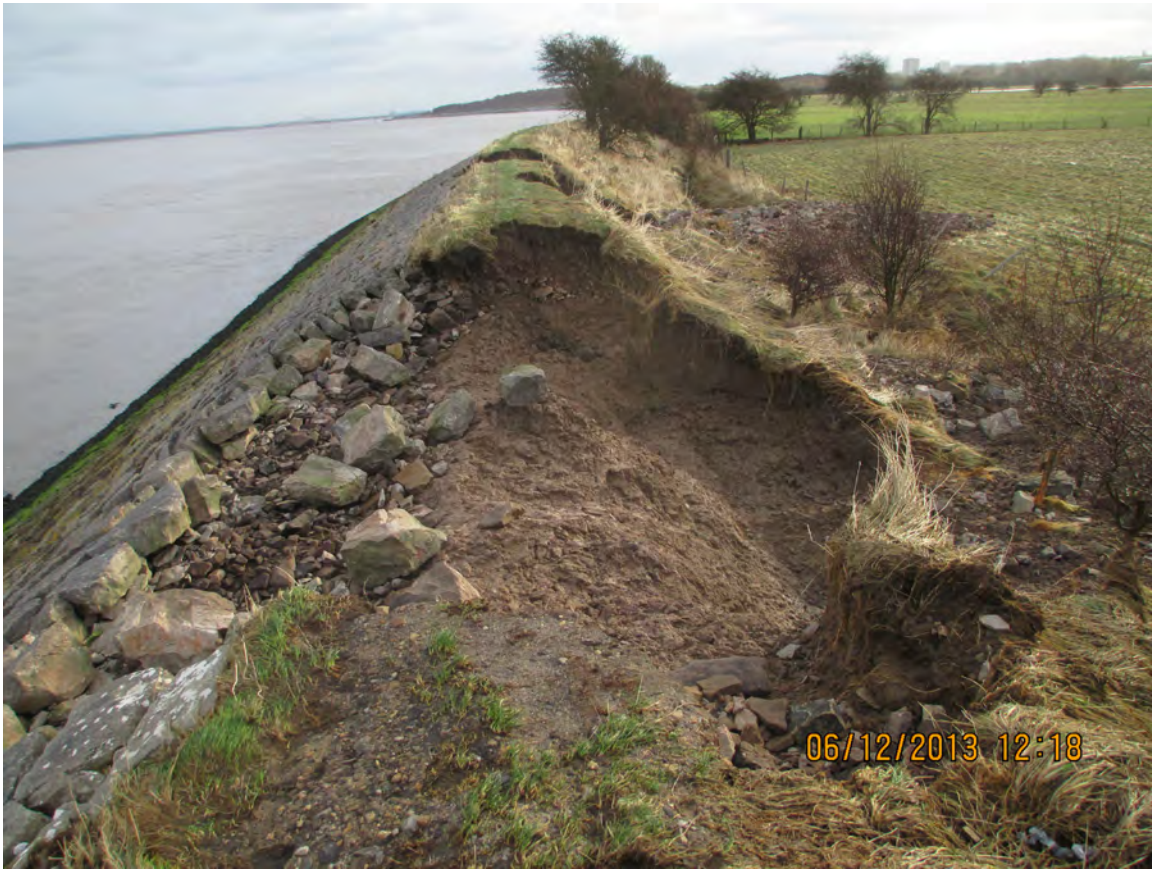
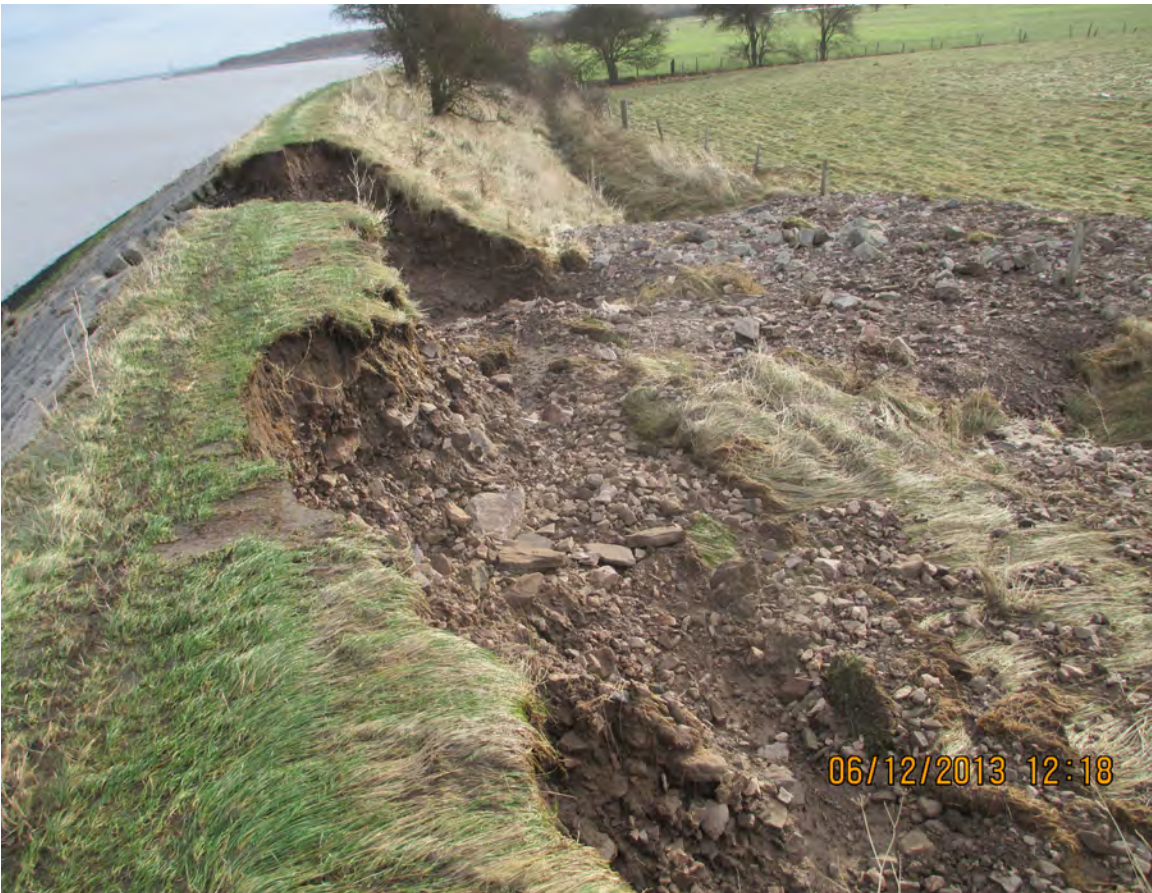
5. Panton Cop, Lord Vivian's Embankment

There is significant damage and numerous breaches along the length of this embankment. Note: Network Rail had only just completed repair works to the crest and rock armour facing on this structure (2013).

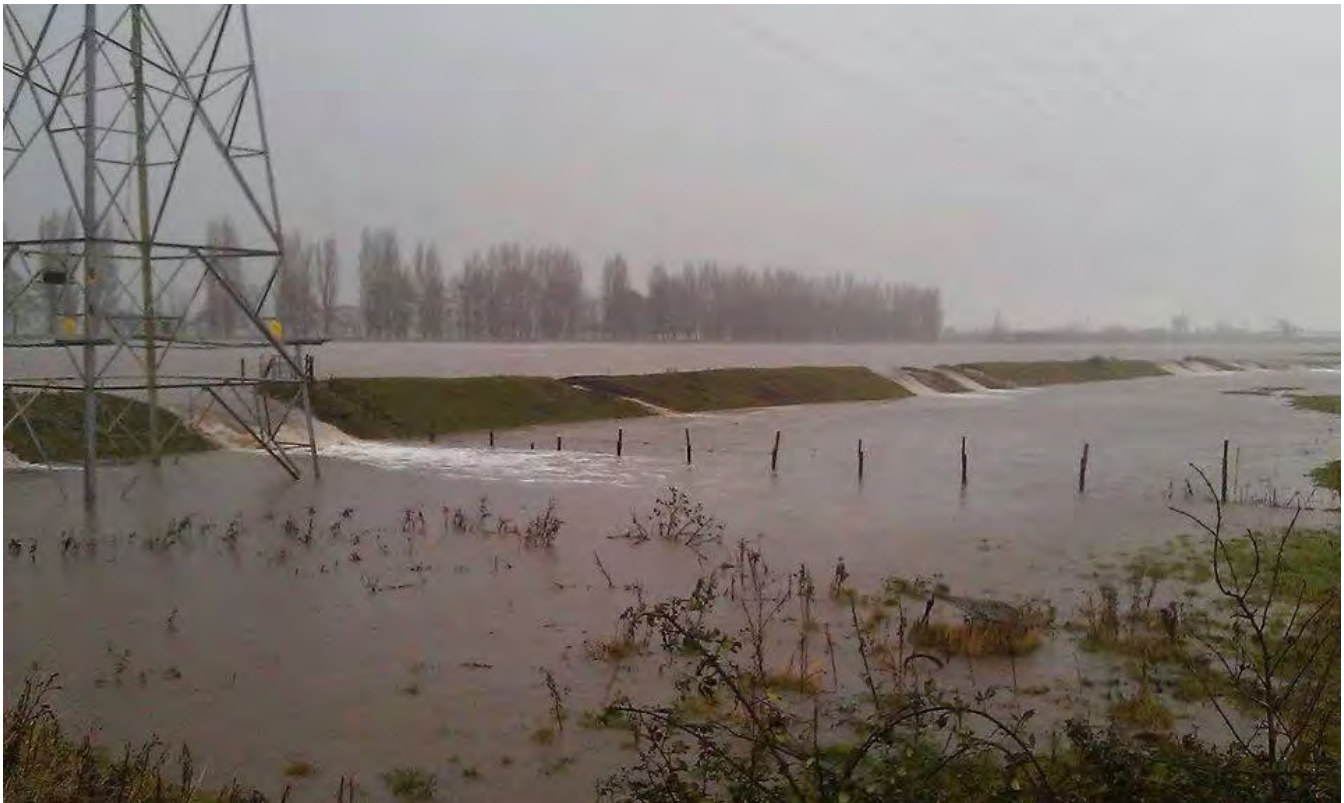
6. Coastal Embankments (& Coastal Path) between Wepre and Blue Bridge

» View upstream (looking East) from near Hawarden Bridge. FCC owned embankment up to the fence, private beyond.

There has been overtopping and/or breaches along this section as can be seen in the above photo.
